**ACCIDENT INVESTIGATION REPORT**

Department of Civil Aviation  
Australia

**PAN-AMERICAN WORLD AIRWAYS INC.  
BOEING 707-321B AIRCRAFT N892PA  
AT SYDNEY (KINGSFORD SMITH)  
AIRPORT, AUSTRALIA  
ON 1st DECEMBER, 1969**

Prepared by:  
Air Safety Investigation Branch Melbourne  
August, 1970

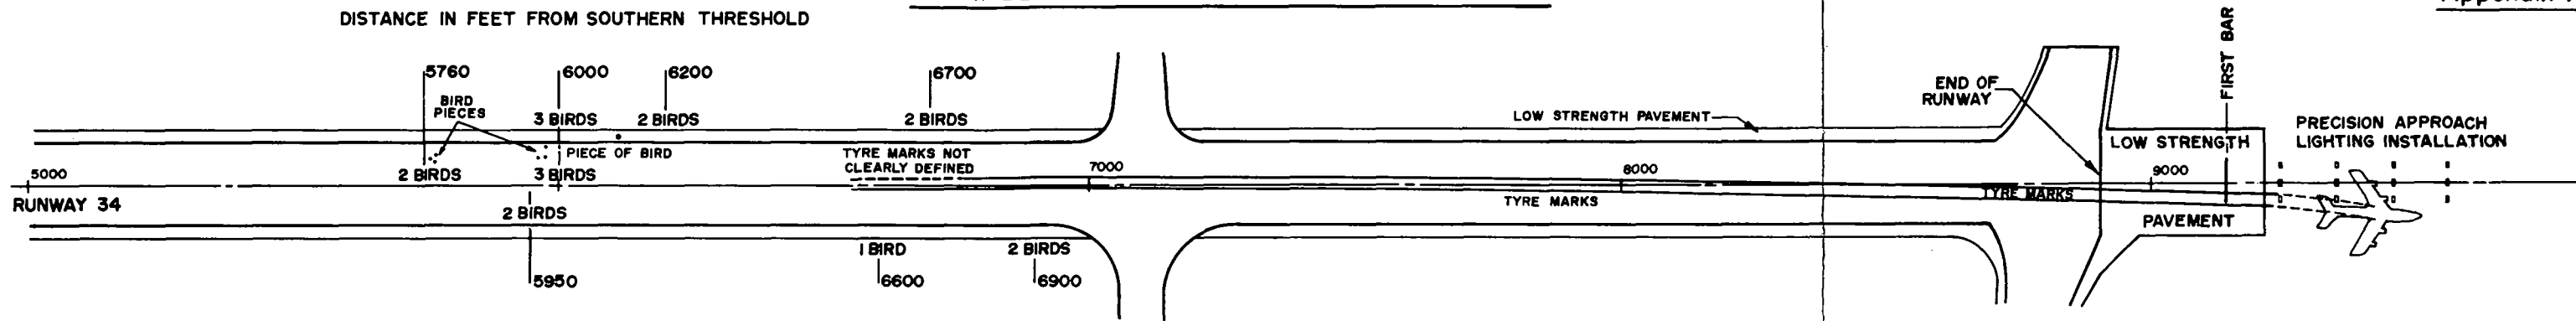
FIG. 1. DECELERATION PATH OF THE AIRCRAFT

The aircraft came to rest with its nose in soft mud 560 feet beyond the end of the runway (260 feet beyond the end of the low strength pavement) and 49 feet to the right of the extended centre line of the runway. At Appendix A - Fig. 1 is a diagram showing the position of the aircraft in relation to the runway, the path taken by the aircraft commencing with the first discernible wheel marks on the runway and the location of seagull carcasses found on and adjacent to the runway. Carcasses and pieces of carcass of approximately 17 seagulls were found on and adjacent to the runway between two points 5,760 feet and 6,900 feet from the southern threshold. The wheel marks of the aircraft could be discerned commencing at a point 6,570 feet from the threshold and until the aircraft came to rest.

The marks made by the aircraft and damage sustained by the approach lighting system provided evidence of the following sequence of failures. As the aircraft passed across the low strength pavement area it ran through the first bar of frangible approach lights, which are mounted on tubular fittings up to 10 inches high. The right hand nose wheel and Numbers 1, 3 and 4 pairs of main wheels, each contacted and broke off an approach light. The two main wheel tyres at Number 2 position passed over a steel mounting tube which had no light attached, and the tyre tracks and tread damage indicate that the tyres were punctured and burst at this point.

As the nose landing gear left the low strength pavement area it was detached from the aircraft when it struck the concrete base and steel mounting frame of an approach lighting barette. The lower part of the Number 2 engine cowling also struck one of the mounting frames in this row of barettes. The failed nose gear remained beneath the fuselage and was carried along with it, passing progressively rearwards along the fuselage and thereby causing substantial damage to the lower fuselage structure.

Shortly after failure of the main gear and about 45 feet before the aircraft came to rest, Number 2 engine contacted the ground resulting in partial upward failure of the nacelle strut and failure of the diagonal brace rear attachment. As the aircraft came to rest, it swung to the left and Number 1 engine also contacted the ground.

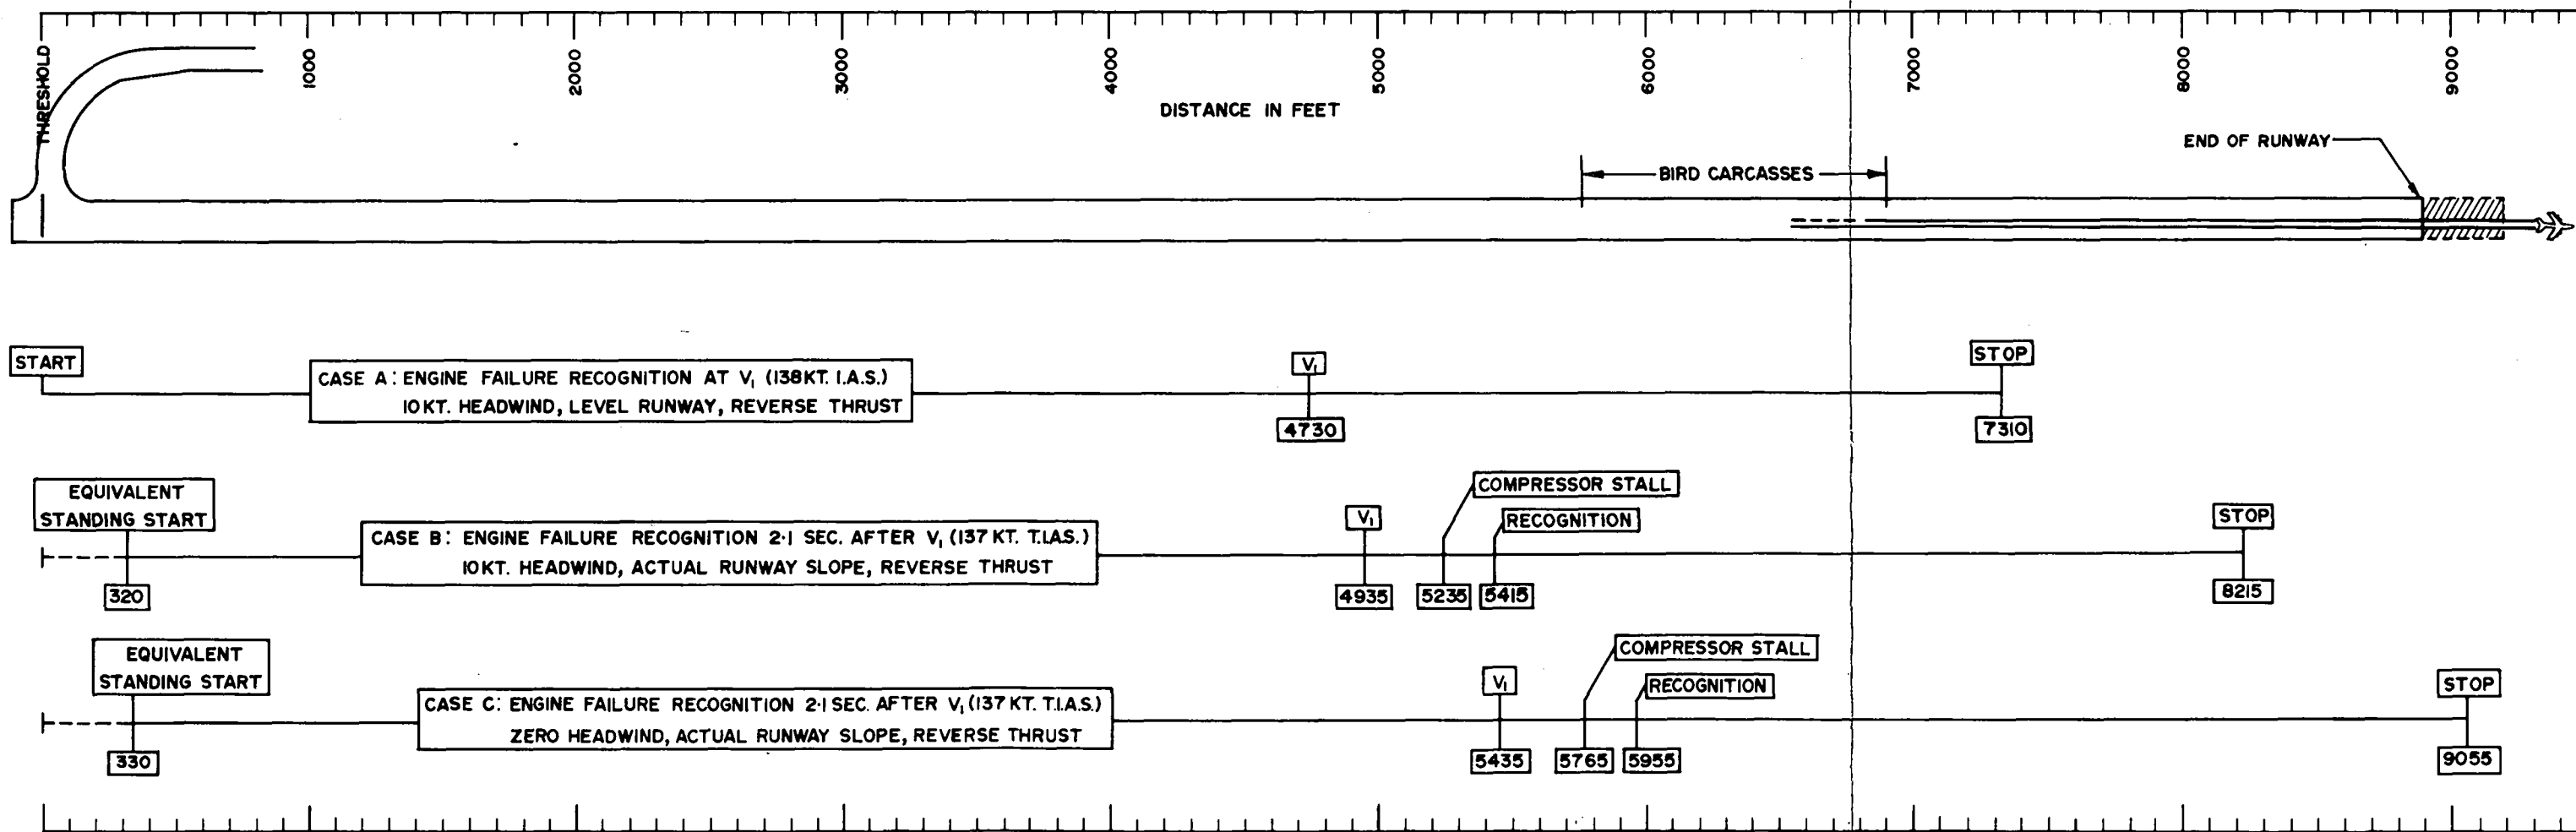
FIG. 2. PERFORMANCE COMPARISONS

At Appendix A - Fig. 2 is a drawing which shows the runway, the bird carcasses, the wheel marks and the final position of the aircraft. For comparison there is shown, at Case A, the position where the aircraft would have come to rest on the basis of a theoretical accelerate/stop manoeuvre. It is assumed in this example that the aircraft gross weight was 309,560 lb, there was a head wind component of 10 knots and the runway was level. It was also assumed that the aircraft was stationary at the runway threshold and that the brakes were released at full engine thrust, that engine failure occurred at the selected  $V_1$  of 138 knots, that recognition was immediate and that transition to deceleration was achieved in the certification delay times of brake application occurring 0.391 seconds after  $V_1$ , throttles cut 1.368 seconds later and then, after a further 1.967 seconds, speed brakes actuated. On these assumptions it is calculated that the total distance travelled by the aircraft before coming to rest would be 7,830 feet measured from the runway threshold and if reverse thrust were used during the deceleration the total distance would be 7,310 feet.

At Appendix A - Fig. 2 are also presented two cases which summarise the results of calculations in this study and are based on the conditions and circumstances of this accident; but one case assumes the existence of a head wind component of 10 knots and the other assumes that there was a zero head wind component. Both cases have taken into account the runway slope, the loss of effective use of runway arising from the rolling start from a side entry onto the runway, the loss of effective use of the runway caused by the aircraft rolling whilst power was progressively applied and the excess speed beyond that of  $V_1$  before the decision to abandon take-off. Both cases have also taken into account the effect of reverse thrust in the deceleration phase. In the case with a 10 knot head wind component, the total distance is 8,215 feet and with a zero head wind the total distance is 9,055 feet; both distances being measured from the southern threshold of the runway.

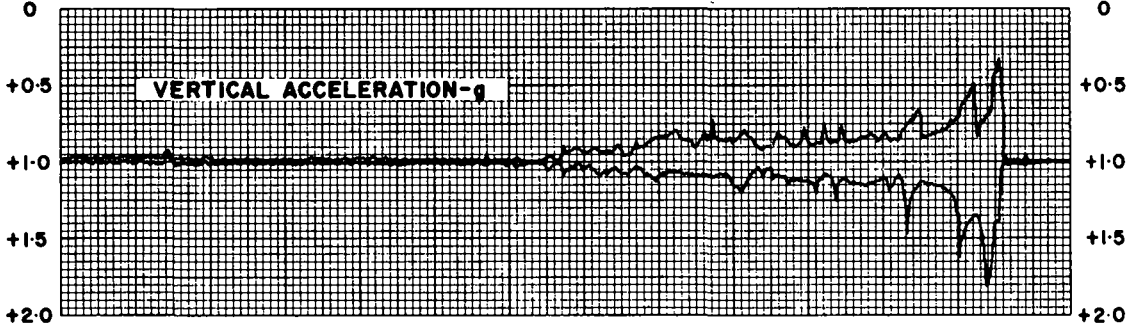
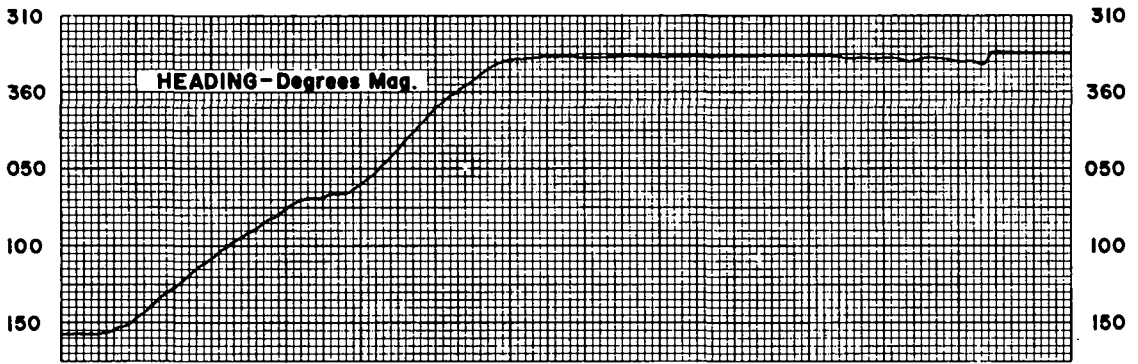
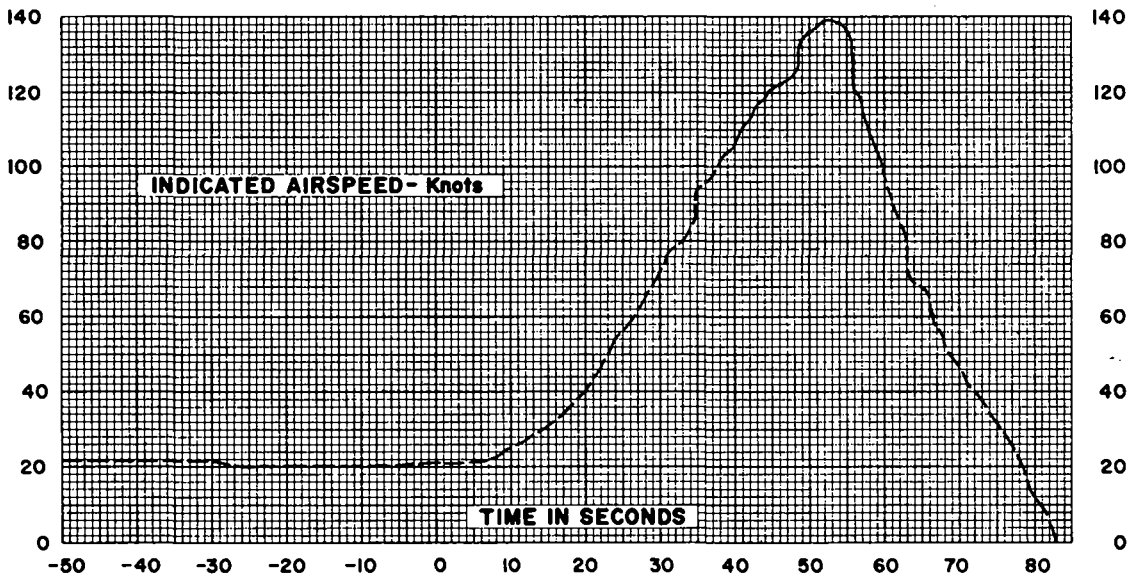
## Graph of Flight Data Recorder Readings Boeing 707-321B N892PA Sydney 1st December 1969

At Appendix C there is a graphical presentation of the flight data record for the period commencing with the turn toward the runway from the heading of 156 degrees maintained on the parallel taxiway and terminating just after the aircraft came to rest.

The heading trace indicates that the aircraft achieved the runway alignment of 336 degrees, 28 seconds after commencing the final turn onto the runway. The heading of 336 degrees was then maintained for 40 seconds after which there was a progressive 4 degree deviation to starboard, a 3 degree correction to port and then a further 5 degree deviation to starboard. The recording indicates that a heading change comprising an almost instantaneous port turn of 7 degrees, to a heading of 333 degrees, occurred as the aircraft came to rest. This turn was confirmed by ground marks and the indicated final heading corresponded with the measured heading of the aircraft at rest.

The vertical acceleration trace showed characteristics of a fairly slow taxi speed during the turn until the aircraft heading reached approximately 30 degrees from runway heading. Over the next 48 seconds, the acceleration trace showed excursions to a maximum of 0.3g which are typical of those inscribed during a take-off. The subsequent recording of a positive "g" of 1.48 and a reversal to 0.66g is consistent with observed recordings of previous landings during periods when reverse thrust was being applied. The largest excursions occurred over the last six seconds of the record of active vertical accelerations. During this period there were peaks of 1.64g, 1.82g, 0.49g and 0.32g which were obviously associated with the aircraft's passage through the area of the approach light installation.
